***INSPECTION AND INTERIOR CLEANING (SEDIMENT REMOVAL)
OF THE GREAT HILL 750,000-GALLON WELDED STEEL
WATER STORAGE TANK***

***TOWN OF NEWMARKET WATER DEPARTMENT
NEWMARKET, NEW HAMPSHIRE***

MAY 23, 2018

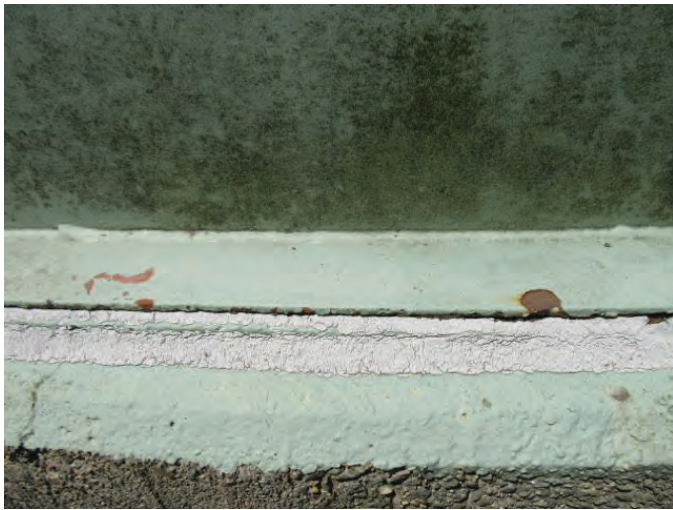
The protective coating applied to the exterior walls appears to have been applied uniformly, meets the AWWA's recommendations and was found having mostly good adhesion value, however numerous areas of coating damage appearing to be the result of objects striking the tank and causing steel exposure were observed throughout approximately 5% of the three lowest rows of wall panels. No obvious fatigue/deterioration of the steel was evident within these 1/4" to 1" diameter areas of steel exposure, rather mild corrosion exists at this time.

A mild to moderate, non-uniform accumulation of mildew throughout the exterior walls causes declined aesthetics.

1 *Exterior Wall With Coating Damage, Exposed Steel, Mild Corrosion And Mild To Moderate Mildew*

It is our recommendation to pressure-wash the exterior wall surfaces at 3,500 P.S.I. and at 3.5 G.P.M. to remove the accumulated mildew from these surfaces and to power tool clean all areas of coating fatigue found throughout these surfaces to remove all corrosion and to prepare the substrate. We then recommend re-coating these areas to halt corrosion, prevent steel fatigue/deterioration and to provide good protection for the steel while improving the overall aesthetics.

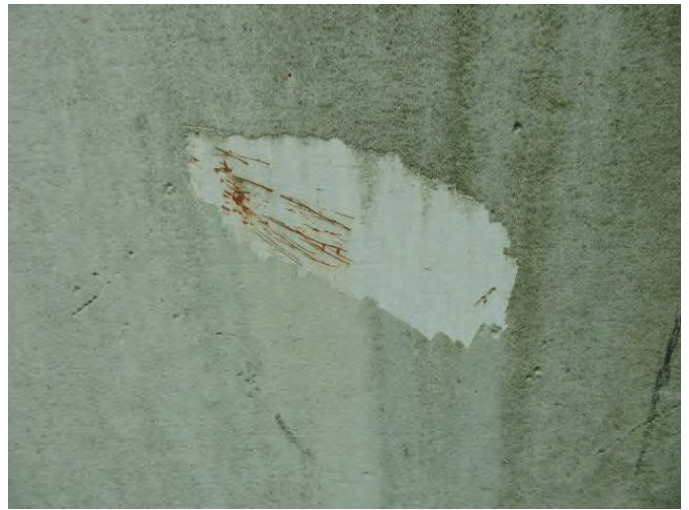
2 *Exterior Wall With Coating Damage, Exposed Steel, Mild Corrosion And Mild To Moderate Mildew*

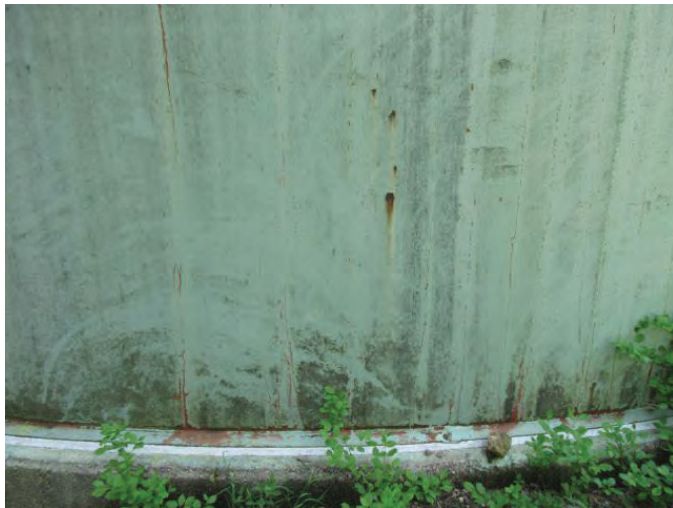
3 *Exterior Wall With Coating Damage, Exposed Steel, Mild Corrosion And Mild To Moderate Mildew*

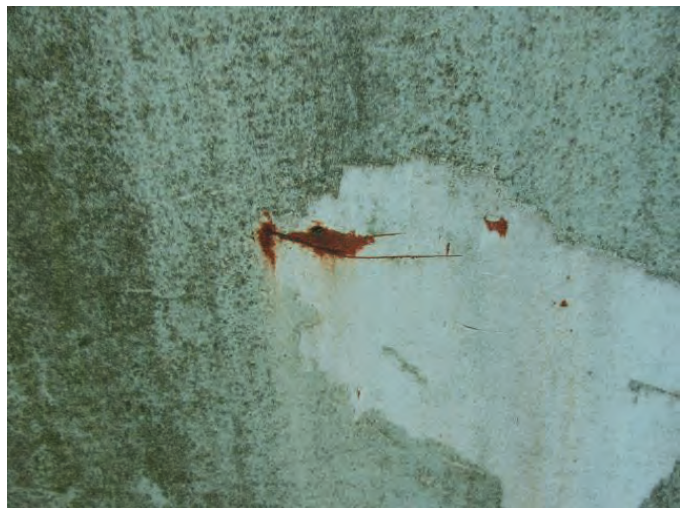
4 *Exterior Wall With Coating Damage, Exposed Steel, Mild Corrosion And Mild To Moderate Mildew*

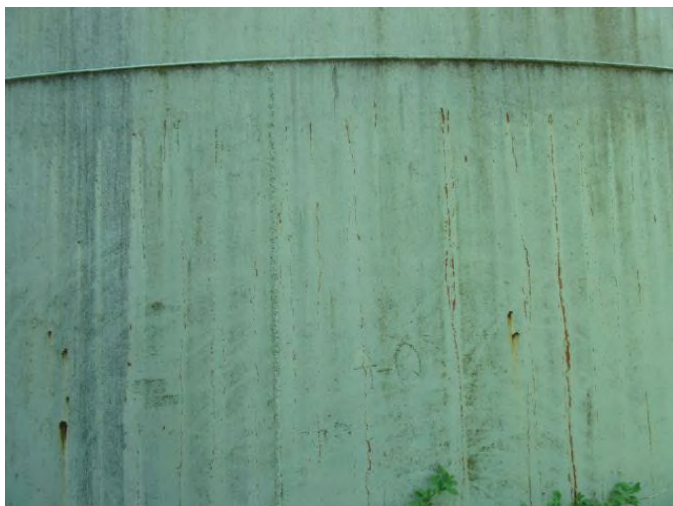
5 *Exterior Wall With Coating Damage, Exposed Steel, Mild Corrosion And Mild To Moderate Mildew*

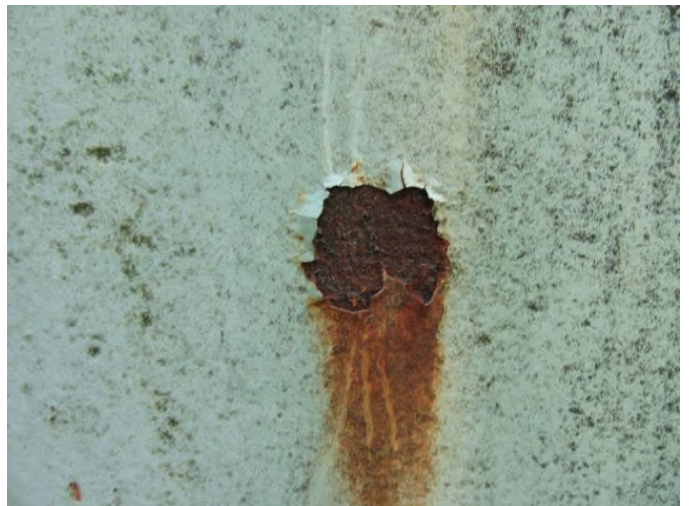
6 *Exterior Wall With Coating Damage, Exposed Steel, Mild Corrosion And Mild To Moderate Mildew*

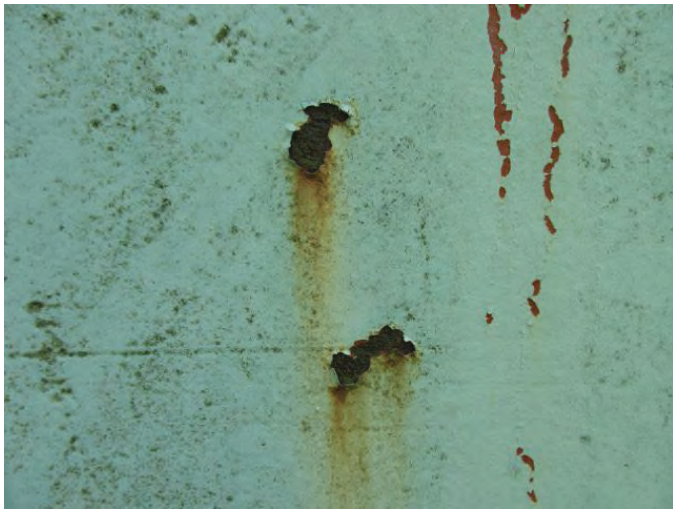
7 *Exterior Wall With Coating Damage, Exposed Steel, Mild Corrosion And Mild To Moderate Mildew*

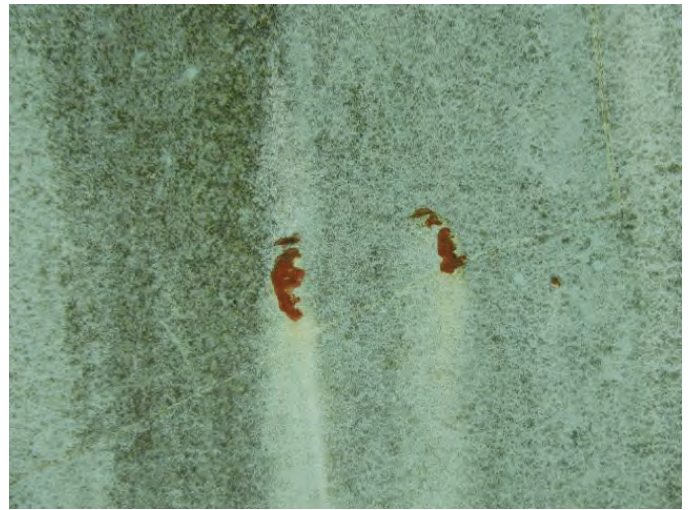
8 *Exterior Wall With Coating Damage, Exposed Steel, Mild Corrosion And Mild To Moderate Mildew*

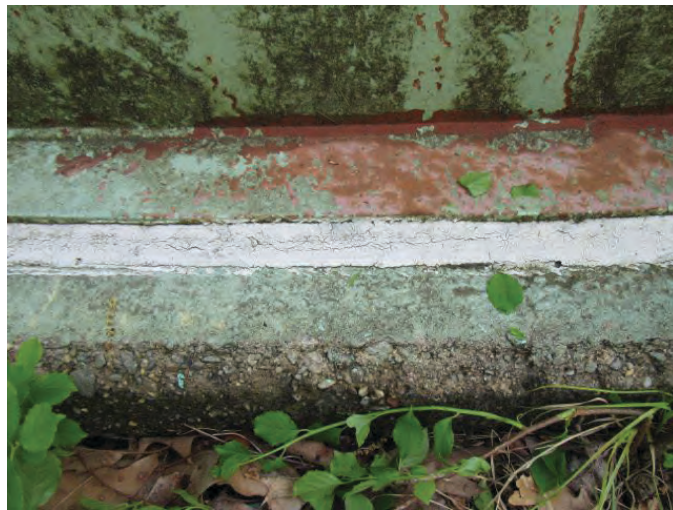
Secondary coating adhesion loss was also observed throughout approximately 10% of the lower 10' of the exterior walls, resulting in exposure of the primary coating.

9 *Exterior Wall With Secondary Coating Loss, Exposed Primary Coating And Mild To Moderate Mildew*

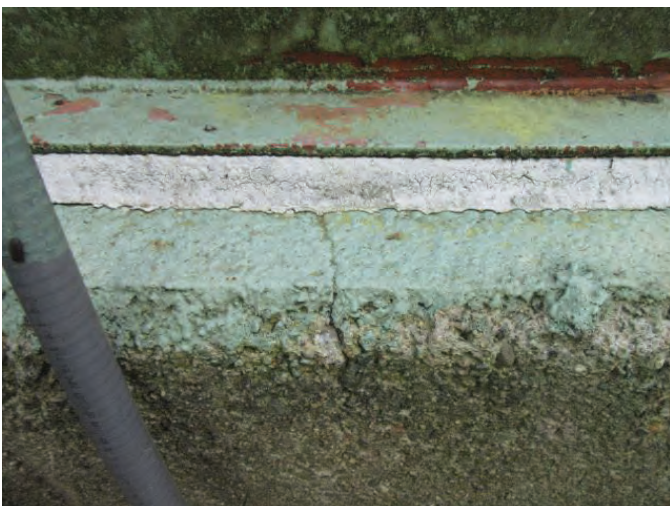
The 3" wide concrete foundation ranges from 1" to 21" in height and was found having tight cracks throughout approximately 5% of these exposed surfaces. These cracks were sounded and appeared to be limited to the surface of the concrete and free of obvious voids or spalls at this time. The protective coating applied to the top face of the foundation was found having good adhesion value, yet no longer seals the cracks found throughout these surfaces.

29 *Concrete Foundation With Tight Cracks*

It is our recommendation that when the exterior walls are pressure-washed that the exposed surfaces of the foundation be pressure-washed to remove all soiling from these surfaces and to then coat all exposed surfaces of the foundation using an epoxy/polyurethane flexible coating to seal all cracks and to seal and protect these exposed concrete surfaces.

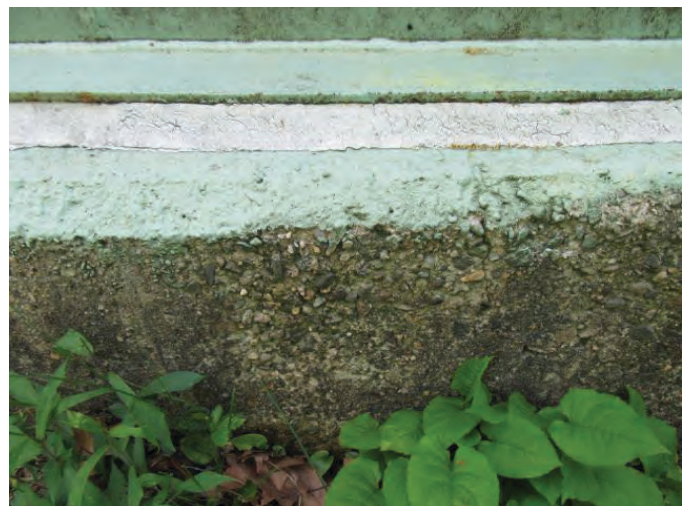
30 *Concrete Foundation With Tight Cracks*

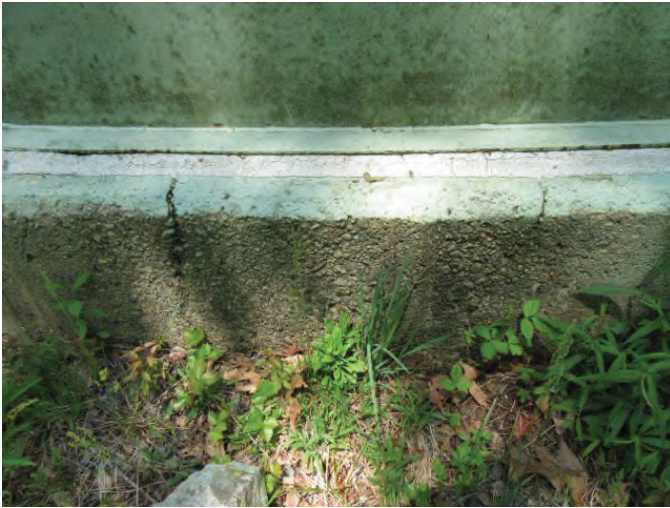
31 *Concrete Foundation With Tight Cracks*

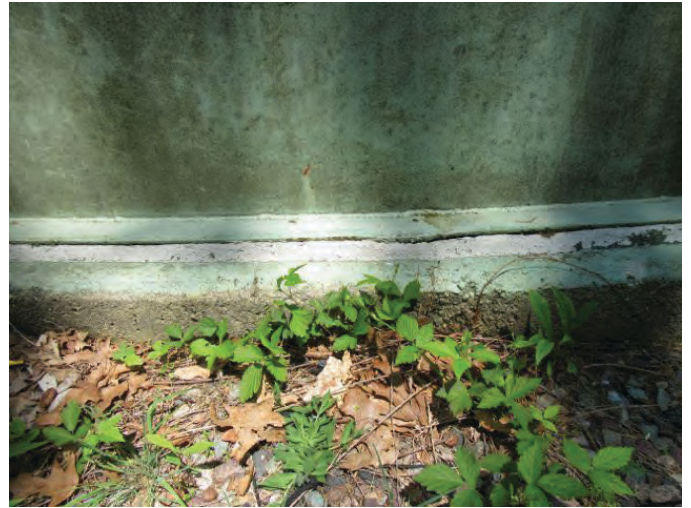
32 *Concrete Foundation With Tight Cracks*

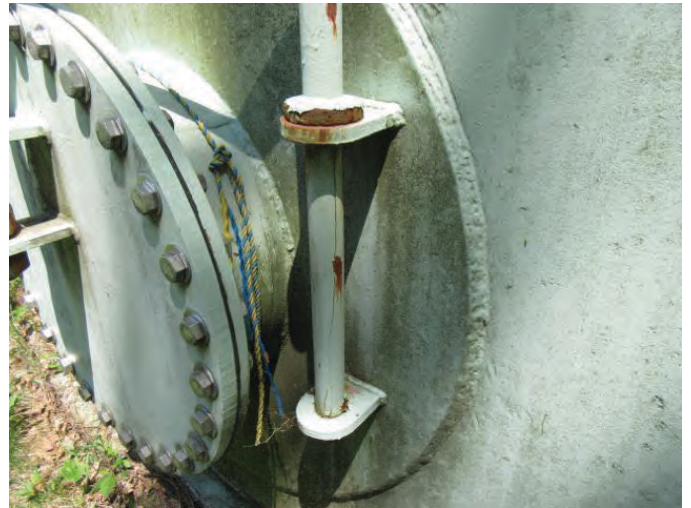
The protective coating applied to the davit support arm was found having mostly good adhesion value, however isolated areas of coating loss were observed throughout approximately 20% of these surfaces causing steel exposure and corrosion. However, this steel davit arm remains sound and free of obvious fatigue/deterioration at this time.

34 *Manway Davit Support Arm With Coating Loss, Exposed Steel And Corrosion*

It is our recommendation to power/hand-tool clean the surfaces of each davit arm to remove all corrosion. We then recommend re-coating the surfaces of each davit arm that do not pivot and applying a moisture barrier (lithium grease) to the pivot points on each davit arm to protect the steel and prevent corrosion.

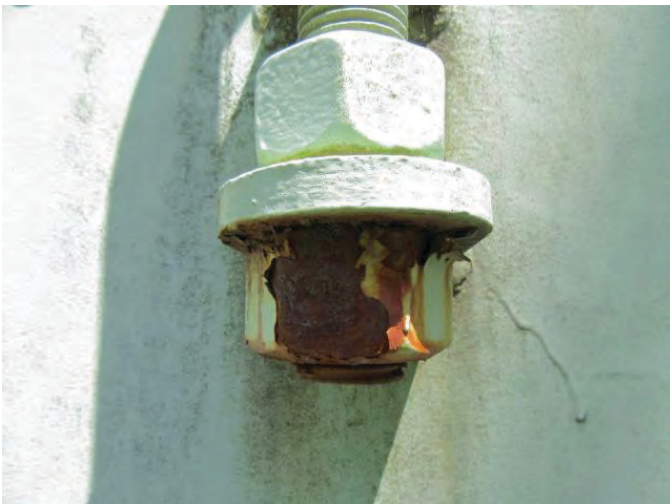
35 *Manway Davit Support Arm With Coating Loss, Exposed Steel And Corrosion*

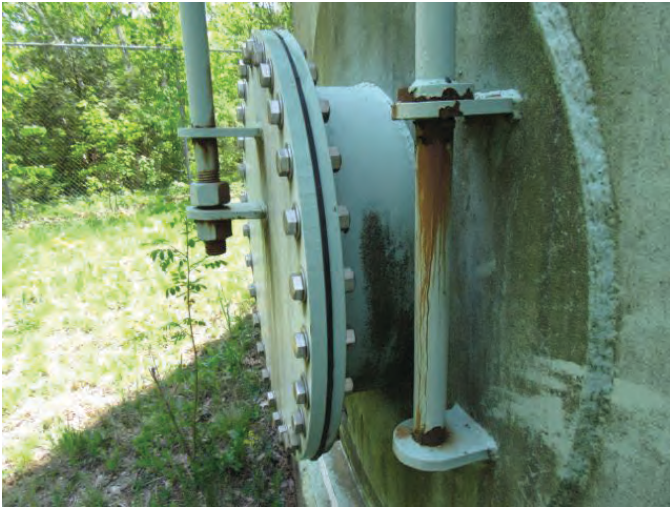
The protective coating applied to the westernmost manway has an average dry film thickness of 10.8 mils, meets the AWWA's recommendation and was found having good adhesion value. The protective coating applied to the davit support arm was found having mostly good adhesion value, however isolated areas of coating loss were observed throughout approximately 20% of these surfaces causing steel exposure and corrosion. However, this steel davit arm remains sound and free of obvious fatigue/deterioration at this time.

37 *Manway Davit Support Arm With Coating Loss, Exposed Steel And Corrosion*

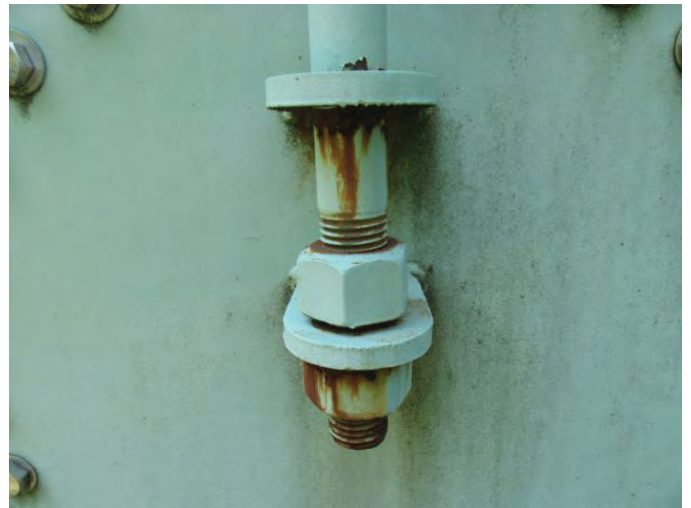
38 *Manway Davit Support Arm With Coating Loss, Exposed Steel And Corrosion*

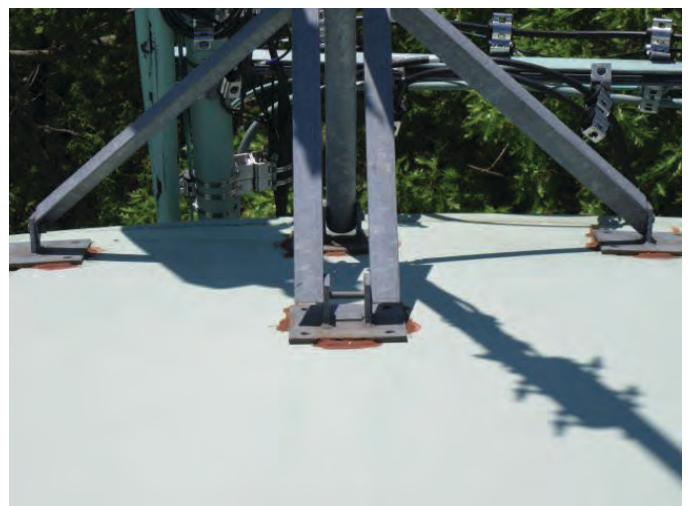
A galvanized steel antenna bracket has been welded to the roof and the welding of this bracket has caused coating damage, steel exposure and corrosion. However, no obvious fatigue/deterioration of the steel was evident at this time.

48 *Antenna Bracket Welded To The Steel Roof Panels With Coating Damage, Exposed Steel And Corrosion*

It is our recommendation to pressure-wash the roof at 2,000 P.S.I. to remove the chalking from the roof and to improve the overall aesthetics, and to power tool clean the surfaces of the roof having coating damage and steel exposure to remove all corrosion and to prepare the substrate. We then recommend re-coating these areas to halt corrosion, prevent steel fatigue and to provide good protection for the steel.

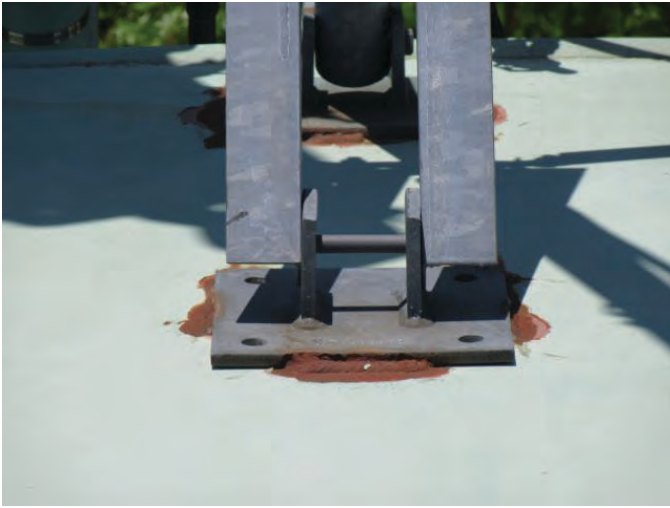
49 *Antenna Bracket Welded To The Steel Roof Panels
With Coating Damage, Exposed Steel And Corrosion*

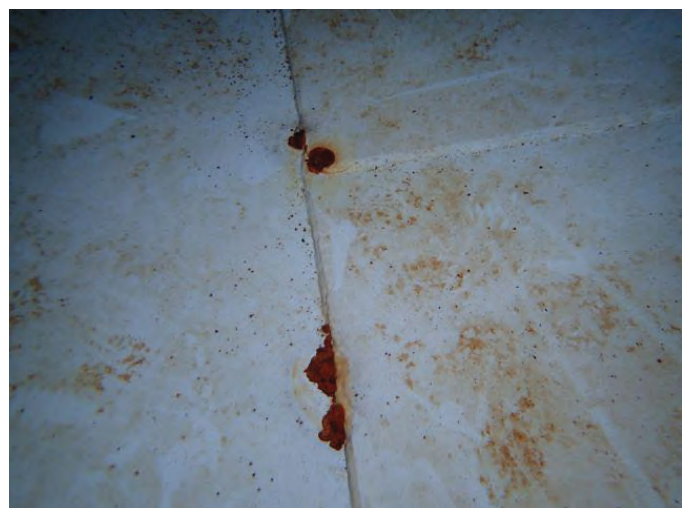
The protective coating applied to these welded steel surfaces has an average dry film thickness of 5.1 mils, is below the AWWA's recommendations, was found having poor adhesion value and is blistering throughout approximately 25% of these surfaces. Approximately 10% of these coating blisters have ruptured, resulting in exposure of the underlying steel. No obvious fatigue/deterioration of the steel was evident within these areas of exposure, rather mild corrosion exists at this time.

60 *Floor With Ruptured Coating Blisters, Exposed Underlying Steel, Mild Corrosion And Mild Staining*

It is our recommendation to abrasive blast the interior floor, wall and overhead surfaces, including all steel components within this tank, to white or near-white metal and to re-coat these surfaces using an A.N.S.I./N.S.F.61 approved coating for use in structures containing potable water to halt corrosion, prevent steel fatigue/deterioration and to provide good protection for the interior steel surfaces of the tank as well as the steel components within the tank. This work should be completed within the next five years, allowing a budget to be prepared to complete this rehabilitation.

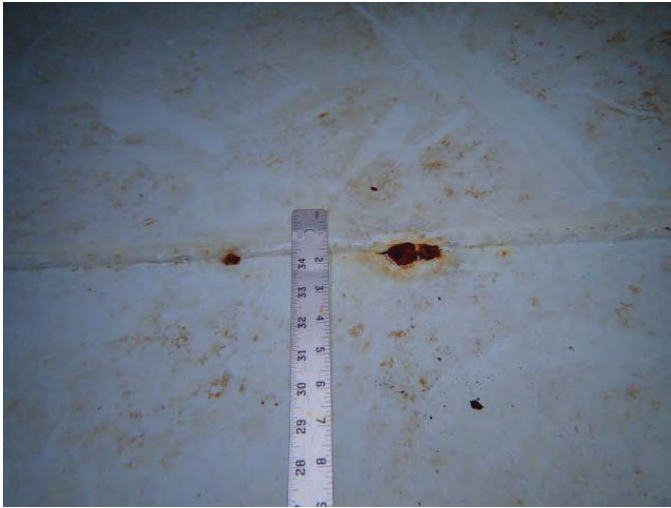
61 *Floor With Ruptured Coating Blisters, Exposed Underlying Steel, Mild Corrosion And Mild Staining*

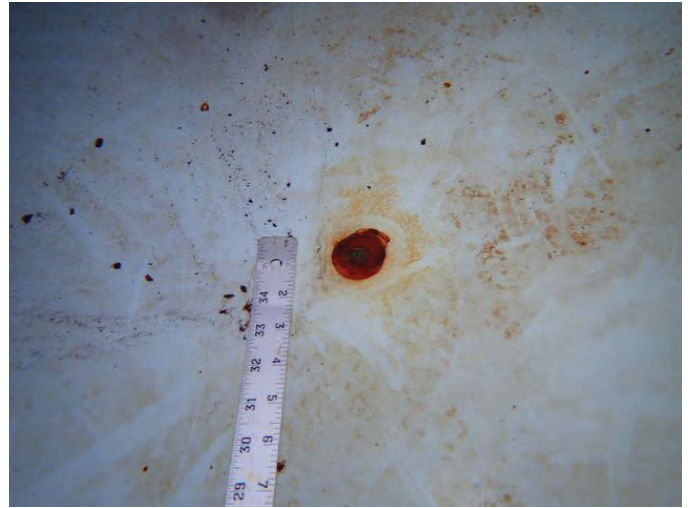
62 *Floor With Ruptured Coating Blisters, Exposed Underlying Steel, Mild Corrosion And Mild Staining*

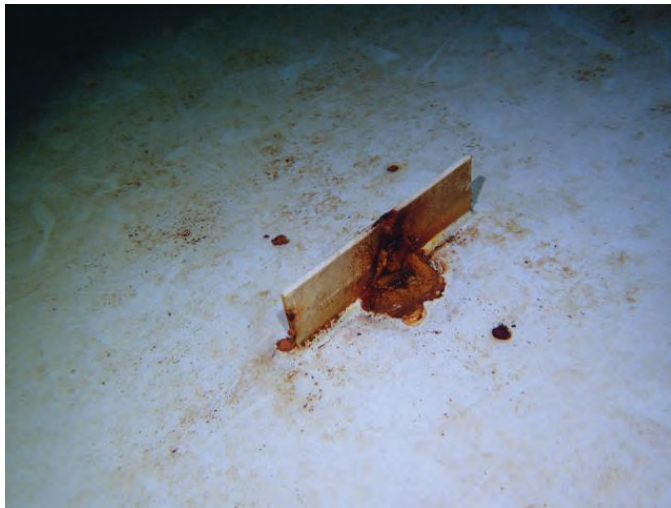
63 *Floor With Ruptured Coating Blisters, Exposed Underlying Steel, Mild Corrosion And Mild Staining*

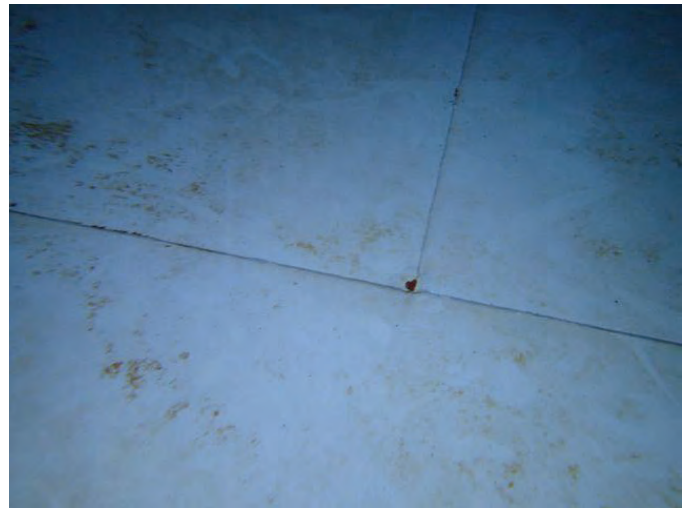
64 *Floor With Ruptured Coating Blisters, Exposed Underlying Steel, Mild Corrosion And Mild Staining*

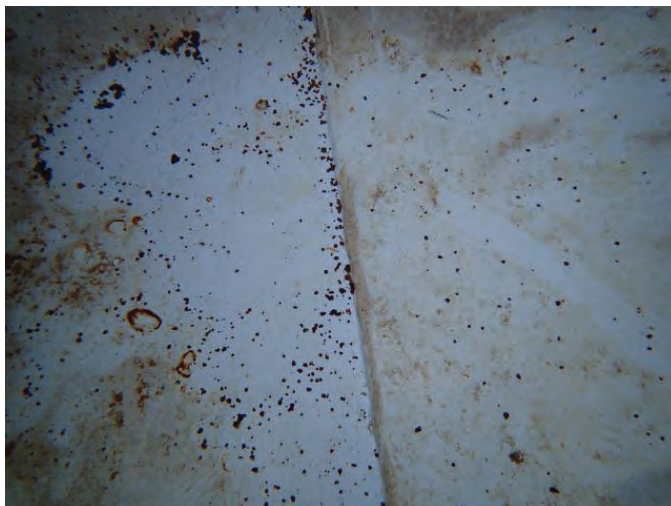
65 *Floor With Ruptured Coating Blisters, Exposed Underlying Steel, Mild Corrosion And Mild Staining*

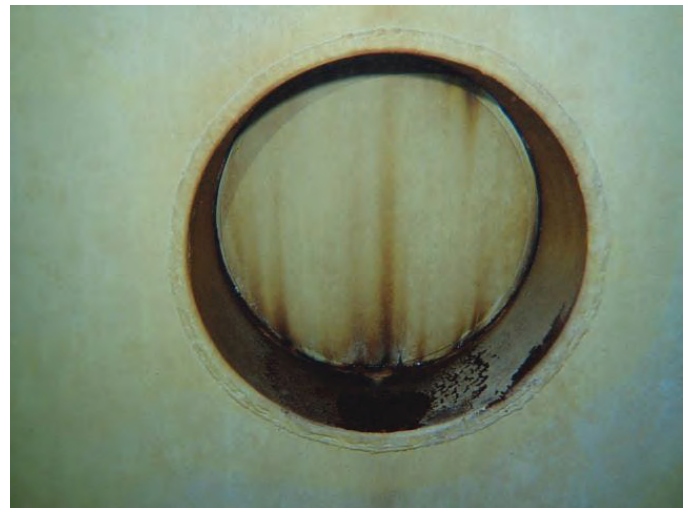
The protective coating applied to the easternmost manway has an average dry film thickness of 5.5 mils, is below the AWWA's recommendation and was found to be blistering throughout approximately 15% of the circumference of the manway trunk at the location where the manway trunk and manway lid contact. No obvious fatigue/deterioration of the steel was evident within these areas of exposure, rather mild corrosion and corrosion staining exists at this time.

70 *Easternmost Manway Trunk With Coating Loss/ Blistering, Mild Corrosion And Corrosive Staining*

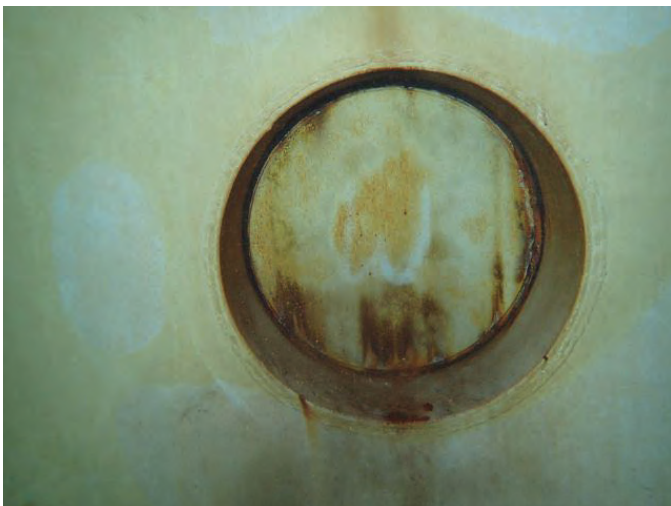
The protective coating applied to the westernmost manway has an average dry film thickness of 1.5 mils, is below the AWWA's recommendations and has nearly expired. Coating blisters were observed throughout approximately 20% of the surfaces of the manway lid and trunk, resulting in exposure of the underlying steel. No obvious fatigue/deterioration of the steel was evident within these areas of exposure, rather mild corrosion and corrosion staining exist at this time.

71 *Westernmost Manway Lid/Trunk With Expired Coating, Exposed Underlying Steel, Mild Corrosion And Corrosive Staining*

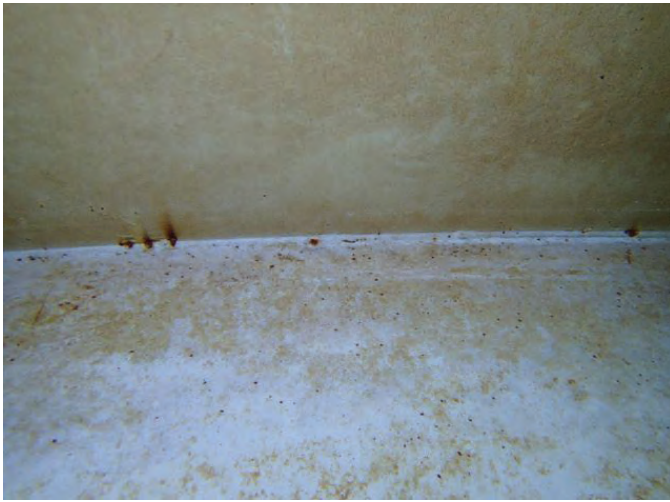
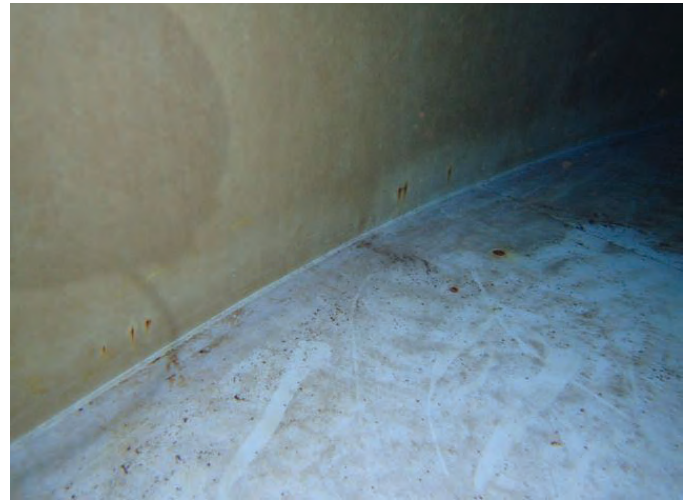
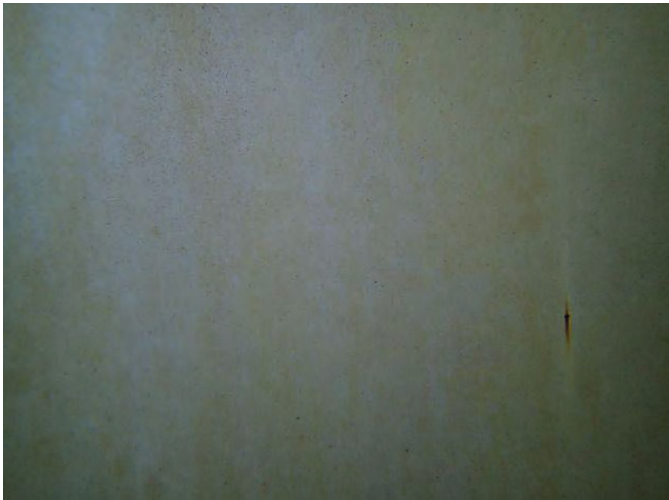
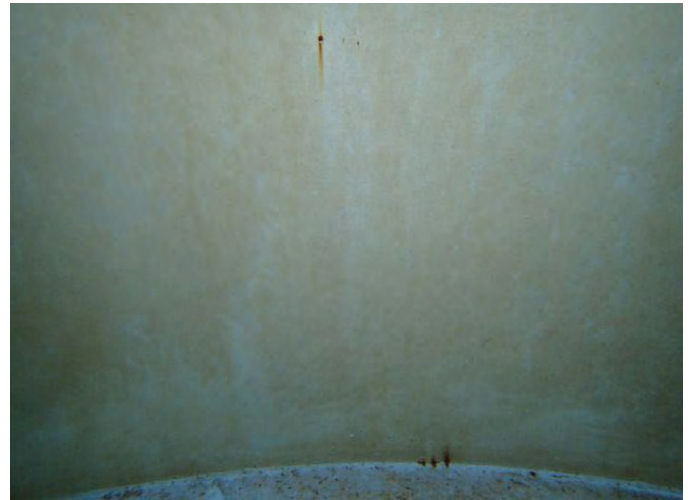
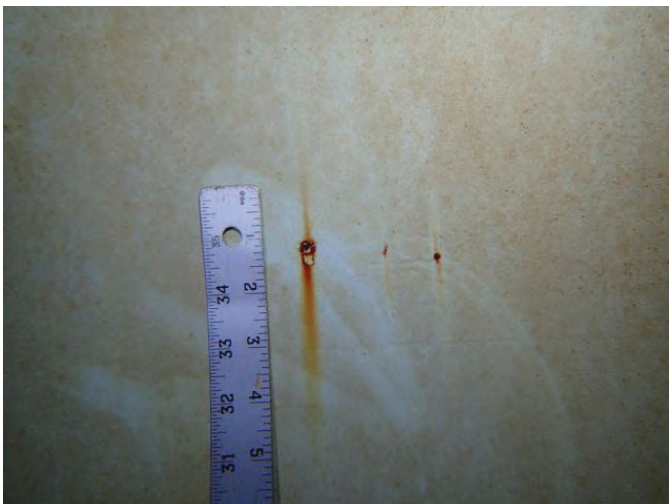
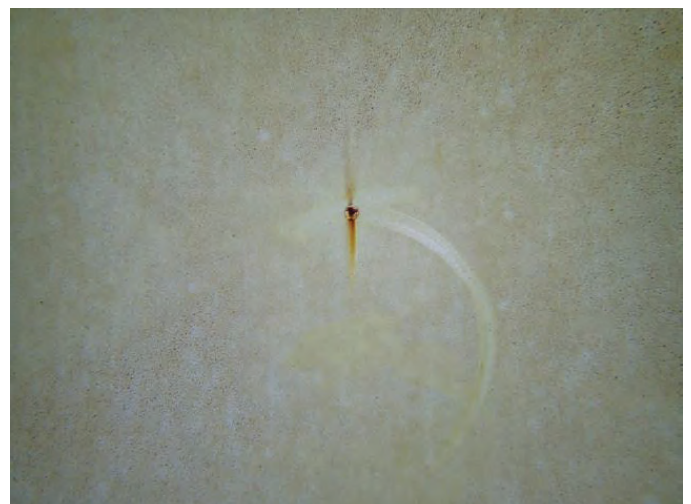
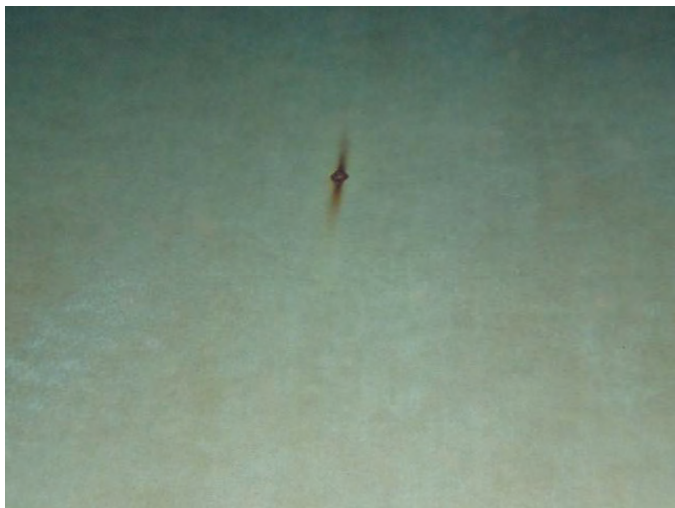
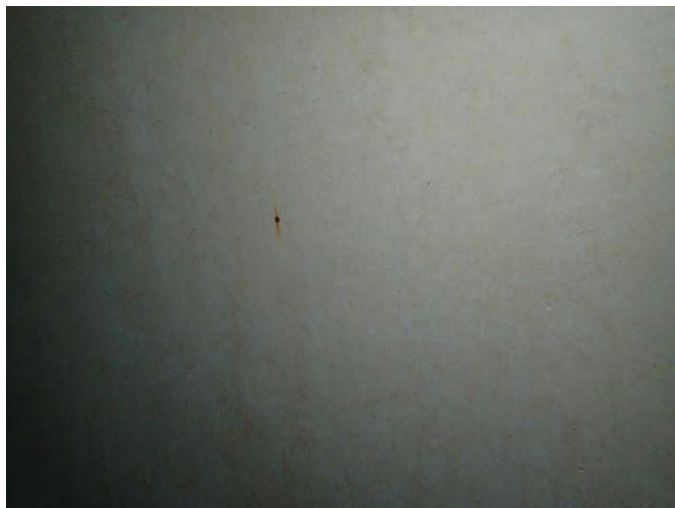
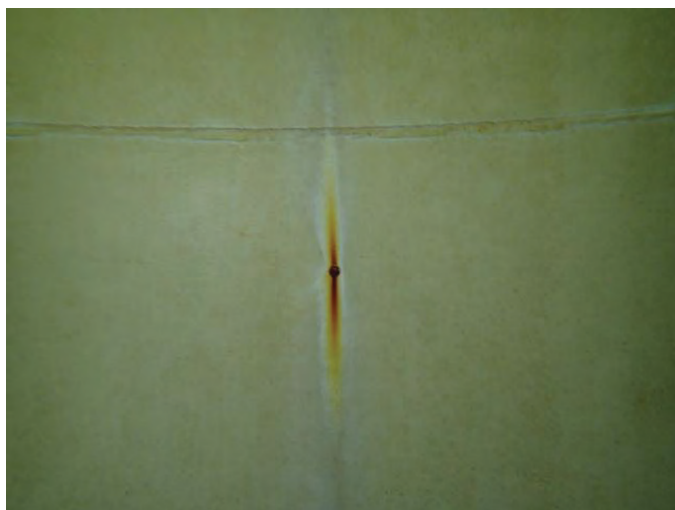
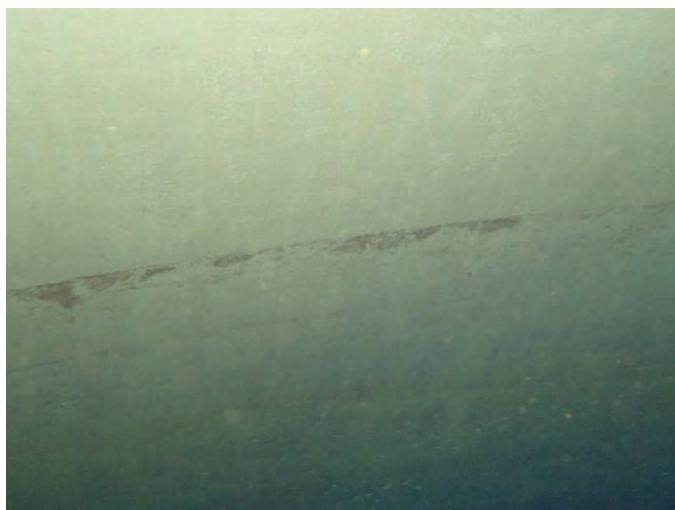
Adhesion loss (blistering and peeling) of the protective coating was also observed throughout approximately 5-10% of these surfaces and was observed throughout all elevations of the interior walls, resulting in exposure of the underlying steel. No obvious fatigue/deterioration of the steel was evident within these 1/8"-1/2" diameter to 10' long by 2" wide areas of exposure, rather mild corrosion exists at this time.

73 *Interior Wall With Coating Loss/Blistering/Peeling, Exposed Underlying Steel, Mild Corrosion And Mild Staining*

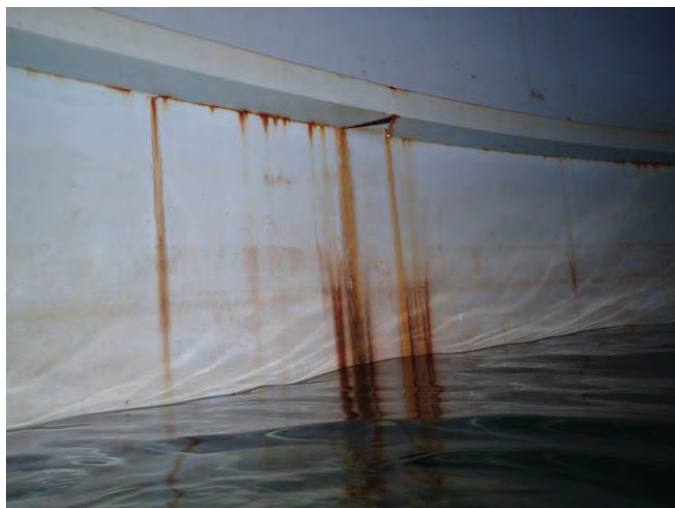
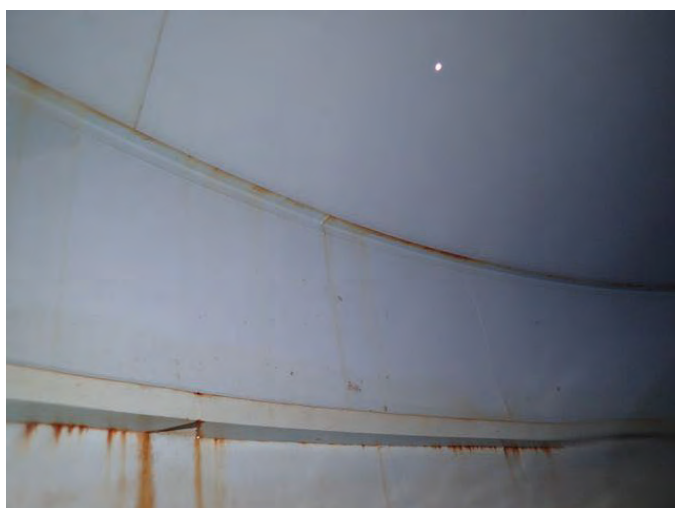
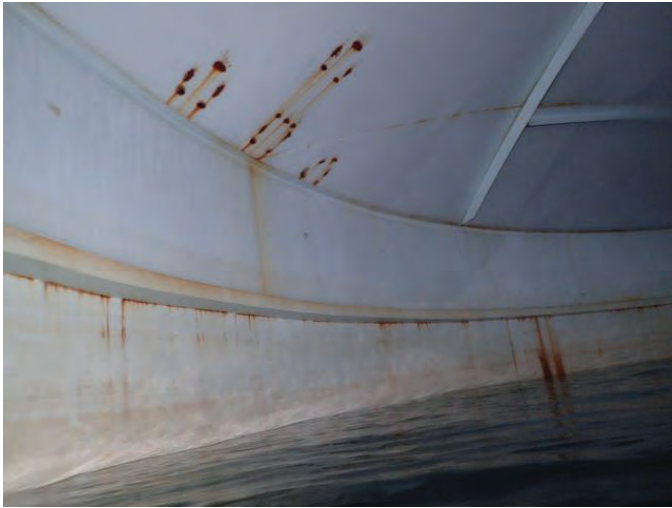
The angle iron painters ring that spans the circumference of the top row of wall panels, located approximately 30" below the junction of where the roof and walls meet, was found securely welded in-place and free of obvious fatigue or failures. The protective coating applied to these steel surfaces appears to have been applied uniformly, however adhesion loss of the protective coating was observed throughout approximately 5% of these surfaces resulting in exposure of the underlying steel. No obvious fatigue (pitting) of the steel was evident within these areas of exposure, rather mild corrosion and corrosion staining exists at this time.

83 *Angle Iron Painters Ring With Coating Loss, Exposed Underlying Steel, Mild Corrosion And Mild Staining*

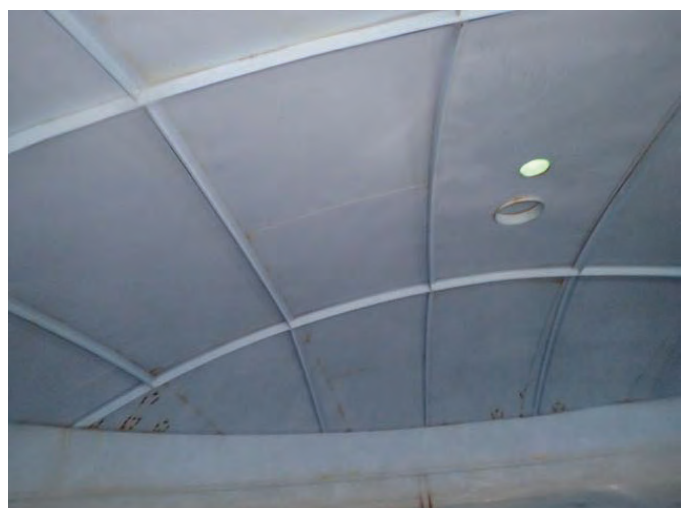
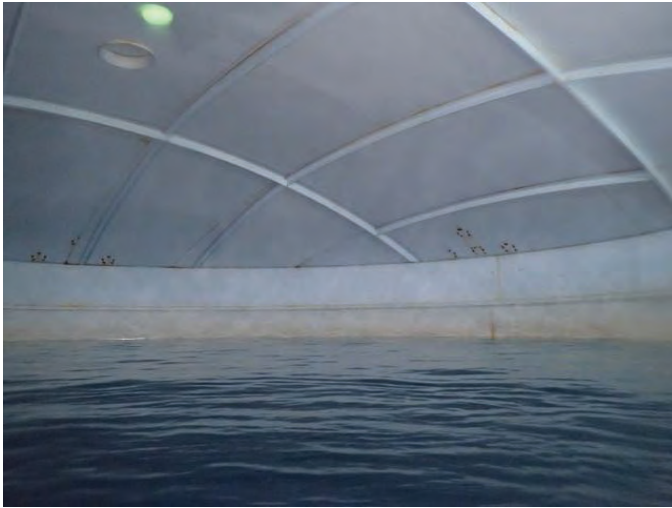
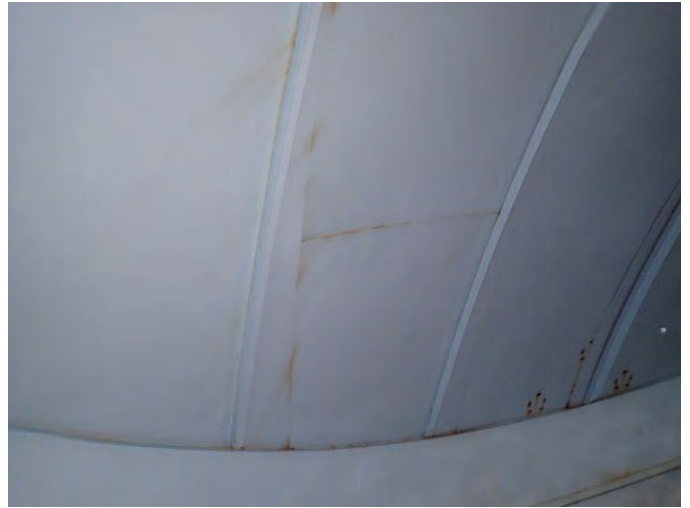
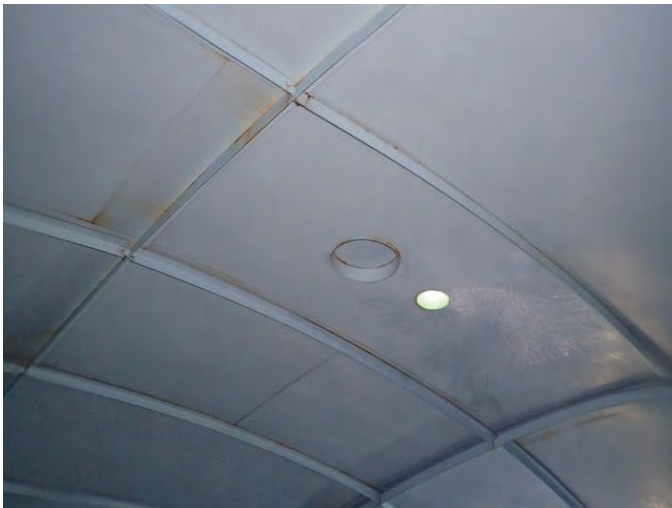
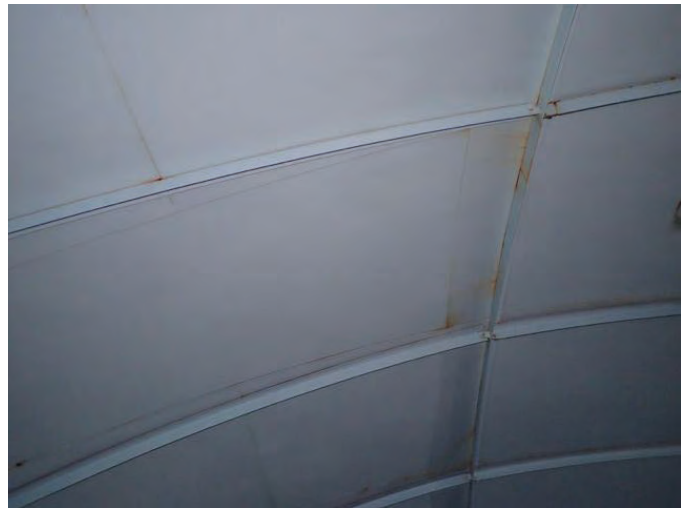
The protective coating applied to the steel panels and angle iron supports appears to have been applied uniformly, meets the minimum dry film thickness recommended by the AWWA and remains having mostly good adhesion value. However, a rust stain was observed throughout approximately 35% of the edges of the steel panels and angle iron supports, while numerous areas of coating damage throughout the outer circumference of the overhead that appeared to be the result of the welding completed on the exterior of the roof has resulted in exposure of the underlying steel. Mild corrosion exists within these areas of steel exposure, however no obvious fatigue/deterioration of the steel was evident at this time.

96 *Steel Overhead Panels And Angle Iron Supports With Rust Staining*

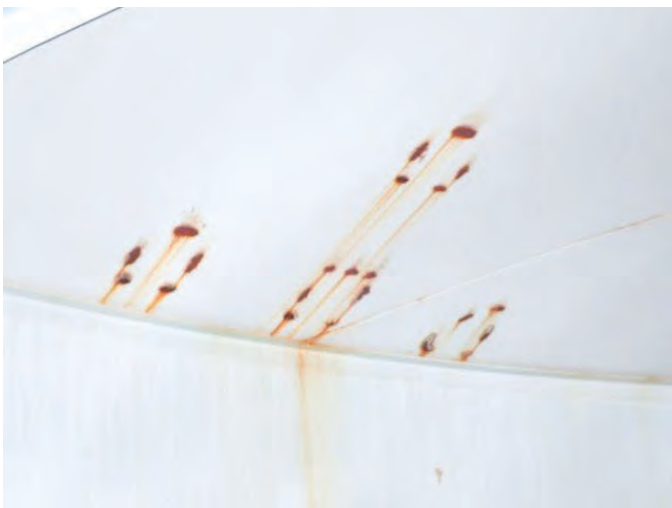
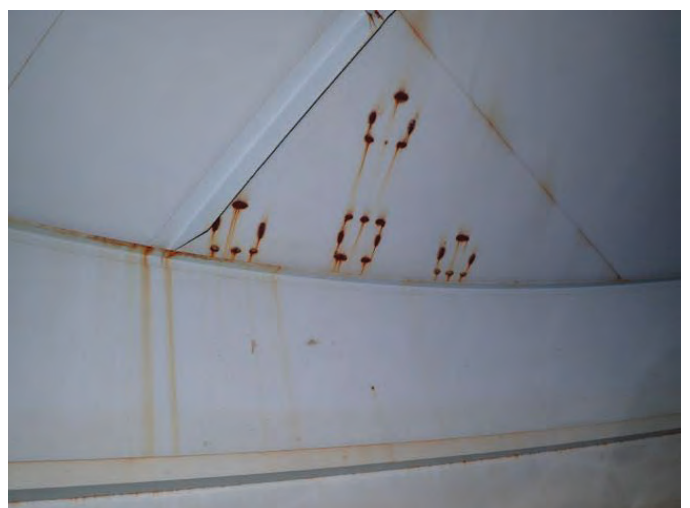
Numerous areas of coating damage were observed throughout the outer circumference of the overhead, which appeared to be the result of the welding completed on the exterior of the roof. These areas of coating damage have resulted in exposure of the underlying steel. Mild corrosion exists within these areas of steel exposure, however no obvious fatigue/deterioration of the steel was evident at the time of this inspection.

101 *Steel Overhead Panels With Coating Damage Exposed Underlying Steel And Mild Corrosion*

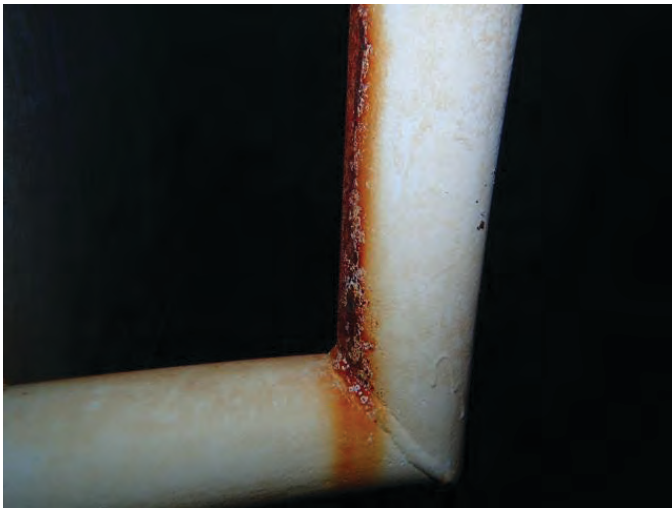
The protective coating applied to this steel pipe appears to have been applied uniformly and was found having mostly good adhesion value, however adhesion loss (blistering) of the protective coating was observed throughout approximately 5% of this pipe resulting in exposure of the underlying steel. No obvious fatigue/deterioration of the steel was evident within these areas of exposure, rather mild surface corrosion exists at this time.

105 *Overflow Pipe With Coating Loss/Blistering, Exposed Underlying Steel And Mild Surface Corrosion*
